Appendix K—Streambank Stability

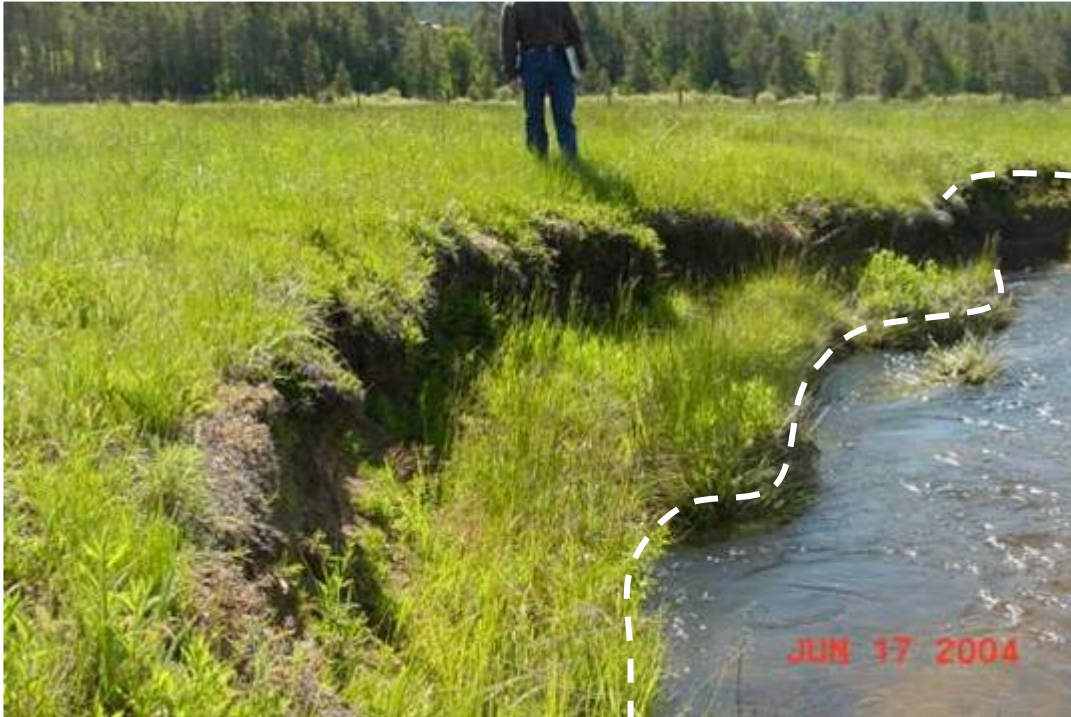
Figure 11—this is a false bank (FB) and is stable.

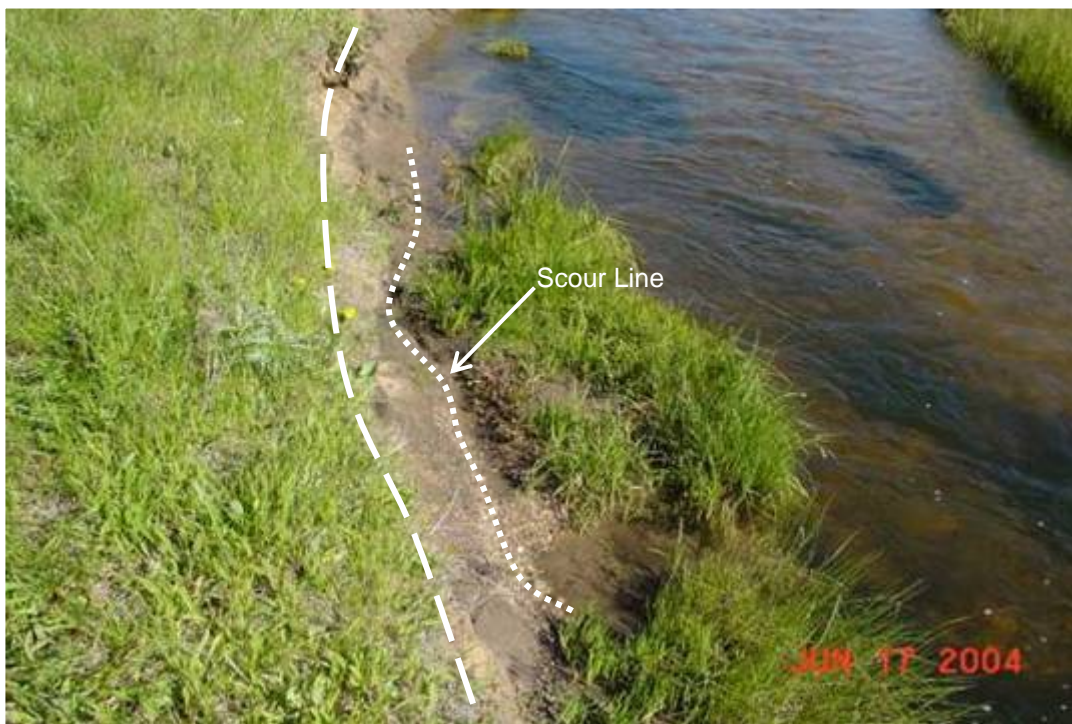
Figure 12—vegetation is not well established between the slump block and the vertical terrace leaving an area subject to erosion. The classification is uncovered/unstable (UU).

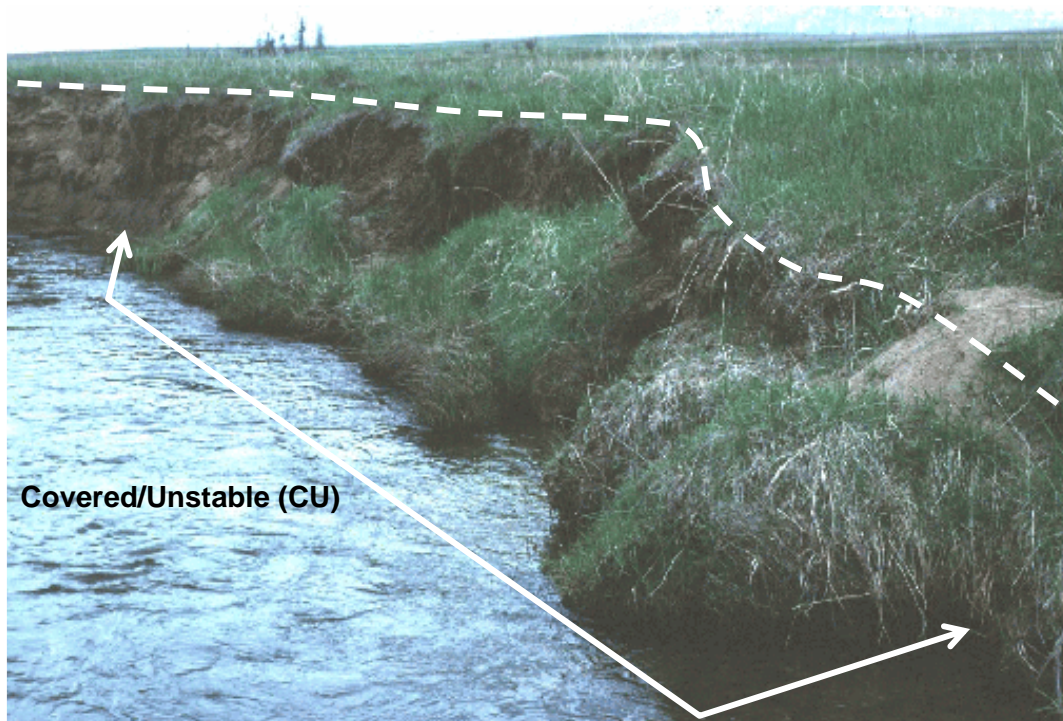
Figure 13—slump blocks and slumping banks with the blocks and attacked bank above the scour line are covered/unstable (CU).

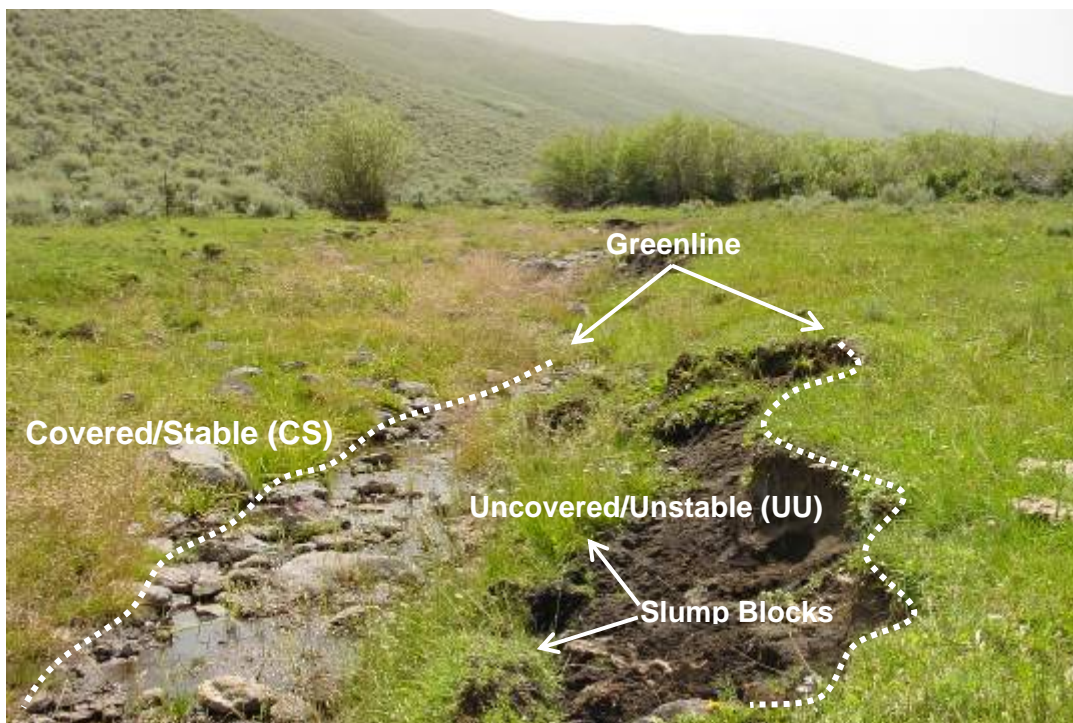
Figure 14—livestock trampling caused slump blocks to shear and push into the stream along the streambank resulting in a classification of the streambank of uncovered/unstable (UU).

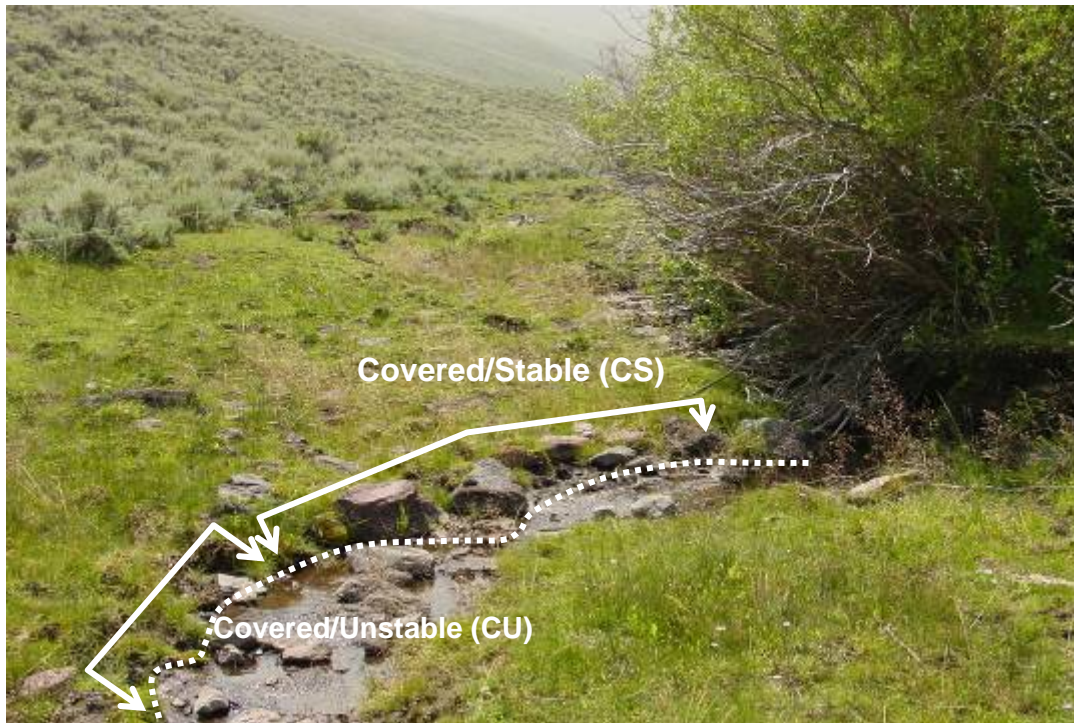
Figure 15—livestock and/or big game caused slumping banks that result in the covered/unstable (CU) classification. The remainder of the bank is covered/stable (CS).

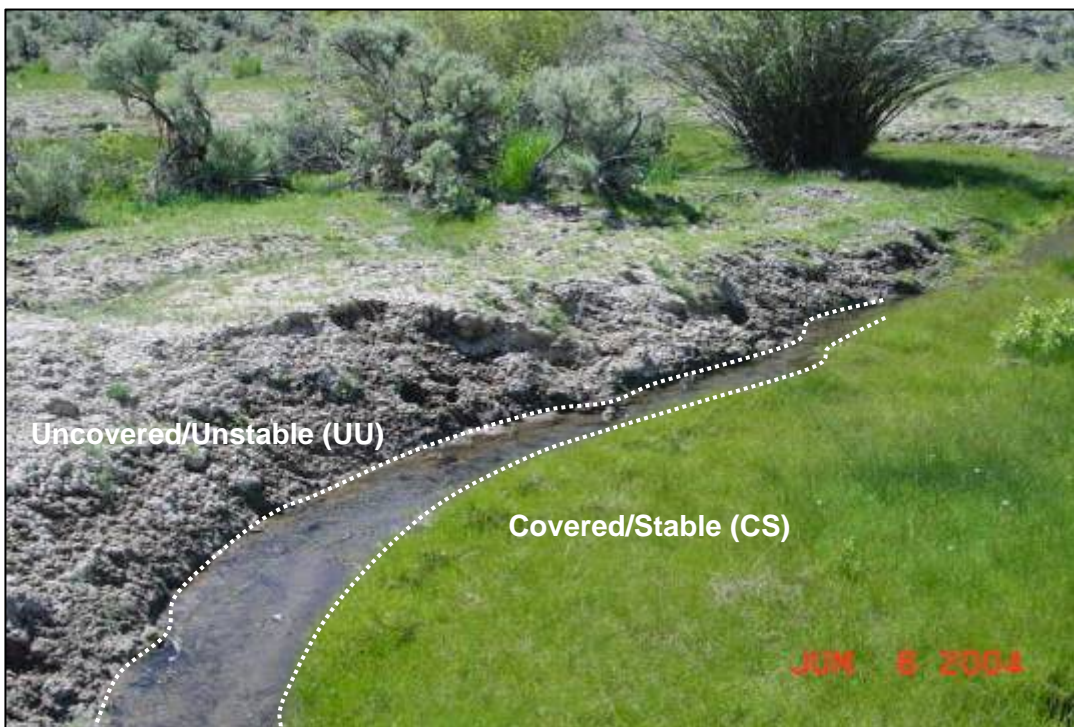
Figure 16—the streambank on one side of the stream is uncovered/unstable (UU) and the other side is covered/stable (CS).

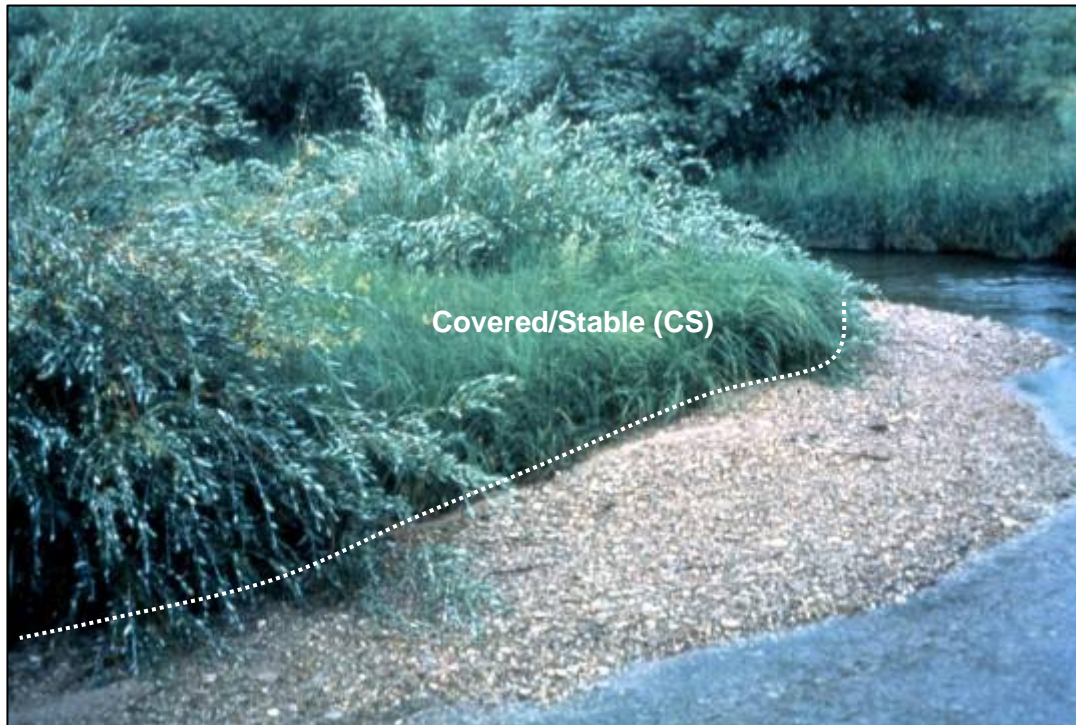
Figure 17—gravel area below the scour line (dotted line) is not considered part of the streambank (see Illustration 1 above). Streambank is covered/stable (CS). Photo – Alma winward

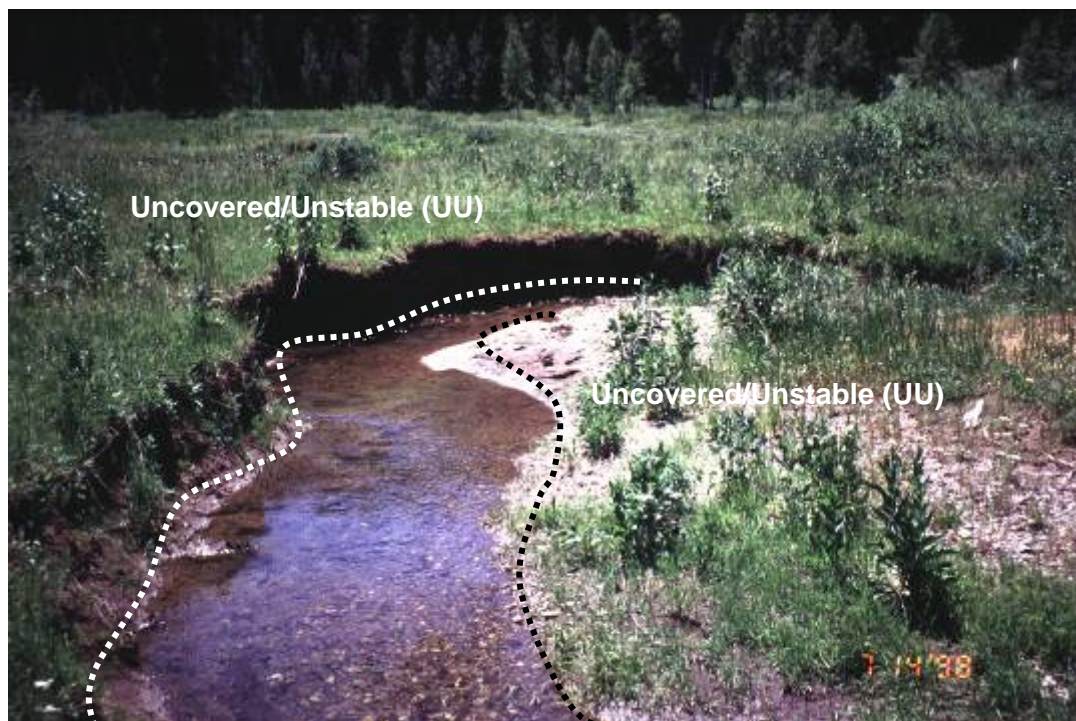
Figure 18—the outside streambank is an eroding streambank and is uncovered/unstable (UU). The point bar has deposition above the scour line, thus it is uncovered/unstable (UU). The scour line is near the waters edge, the lower level of vegetation.
